DOE/EV-0032

Report on the Explosion, Fire, and Oil Spill Resulting in One Fatality and Injury on September 21, 1978, at Well 6 of Cavern 6 at the West Hackberry, Louisiana, Oil Storage Site of the Strategic Petroleum Reserve

November 1978

U.S. Department of Energy
Washington, D.C. 20545

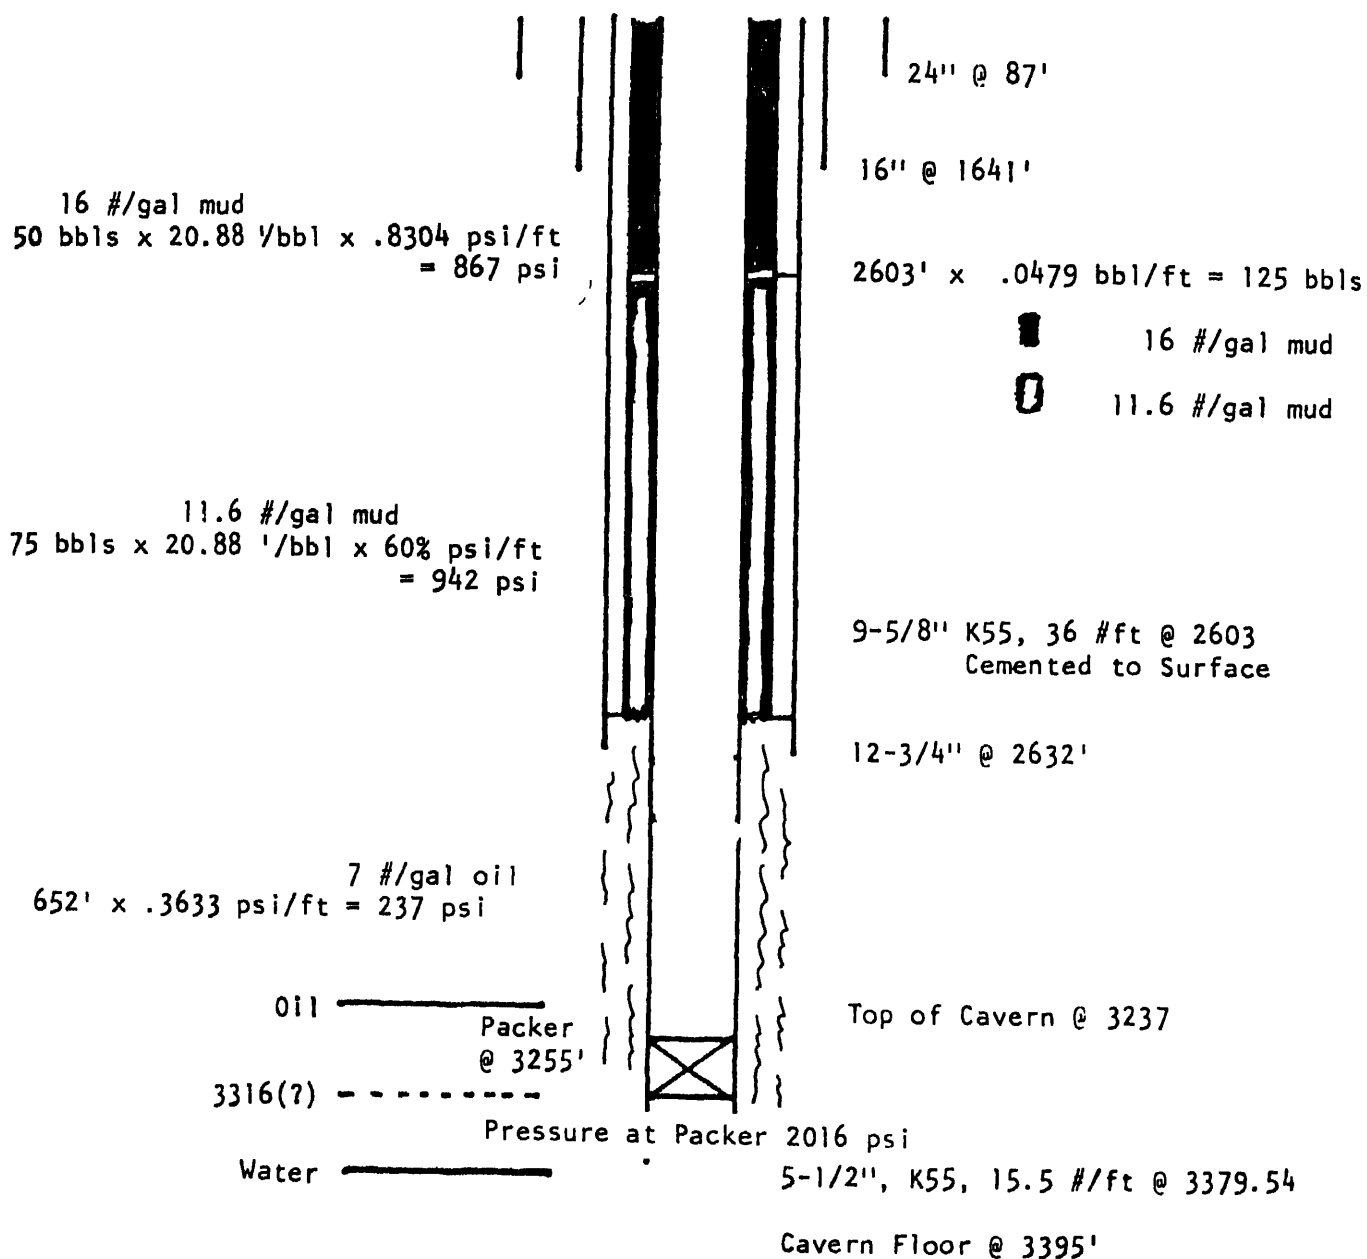
Figure 2-A

Condition on Well 6 with Well Dead
 Before Casing was Pulled.

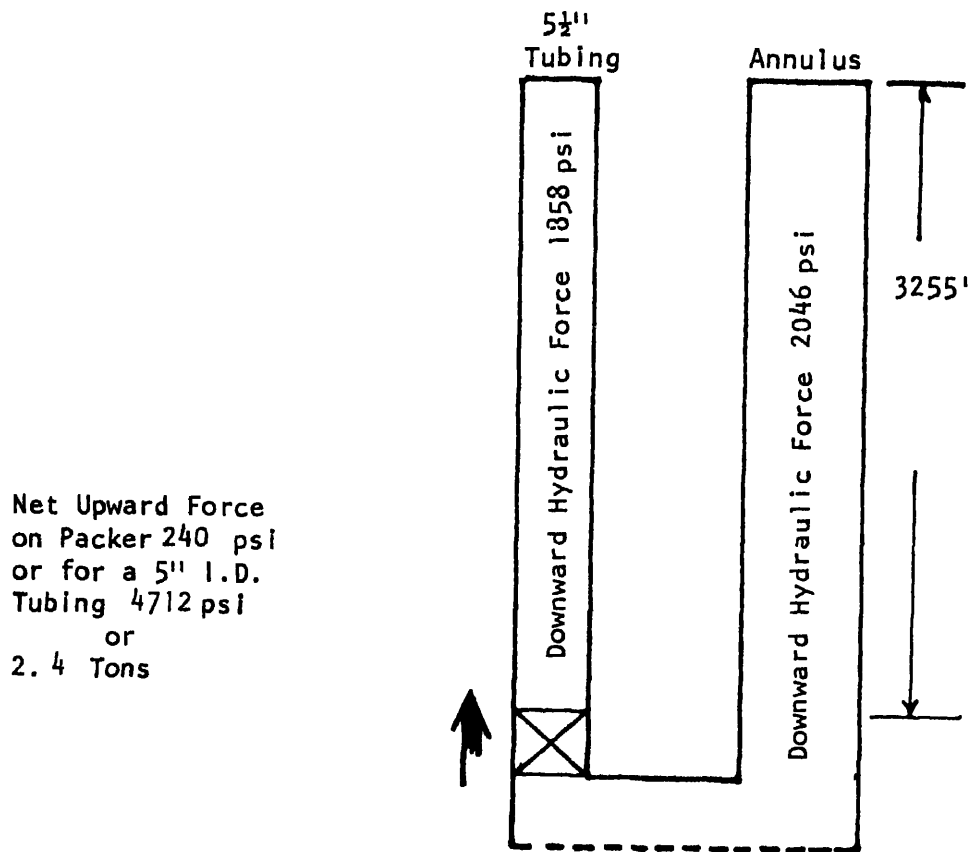
Figure 10.

The pressure opposite the packer would then be 2,046 psi (Figure 10)

Initial downward hydraulic force on the TAM packer was 1,876psi (figure 10).

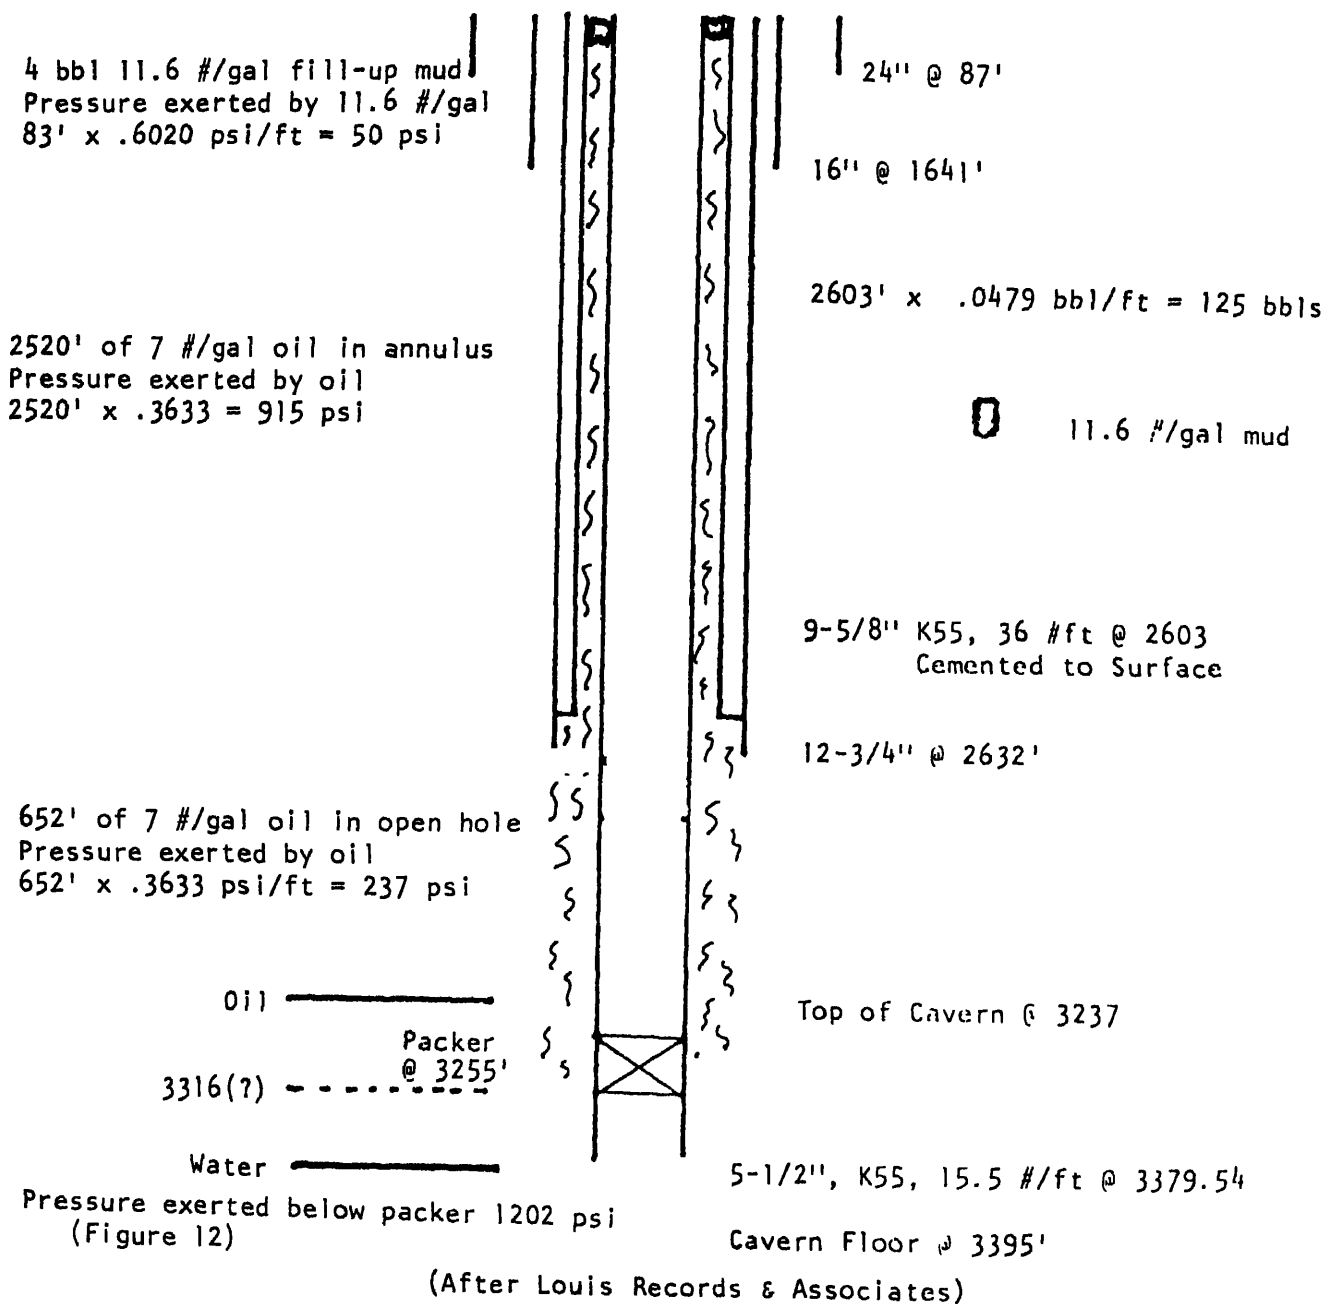
Before pulling the 5-1/2" tubing, the hydraulic pressure in the annulus opposite to the packer would have been 1295 psi (Figure 12) (Figure 2-C).

Figure 2-C
 Cavern Pressure Reduced to 50 psi Potential
 Condition on Well 6 with Well Dead Before
 Pulling Casing.

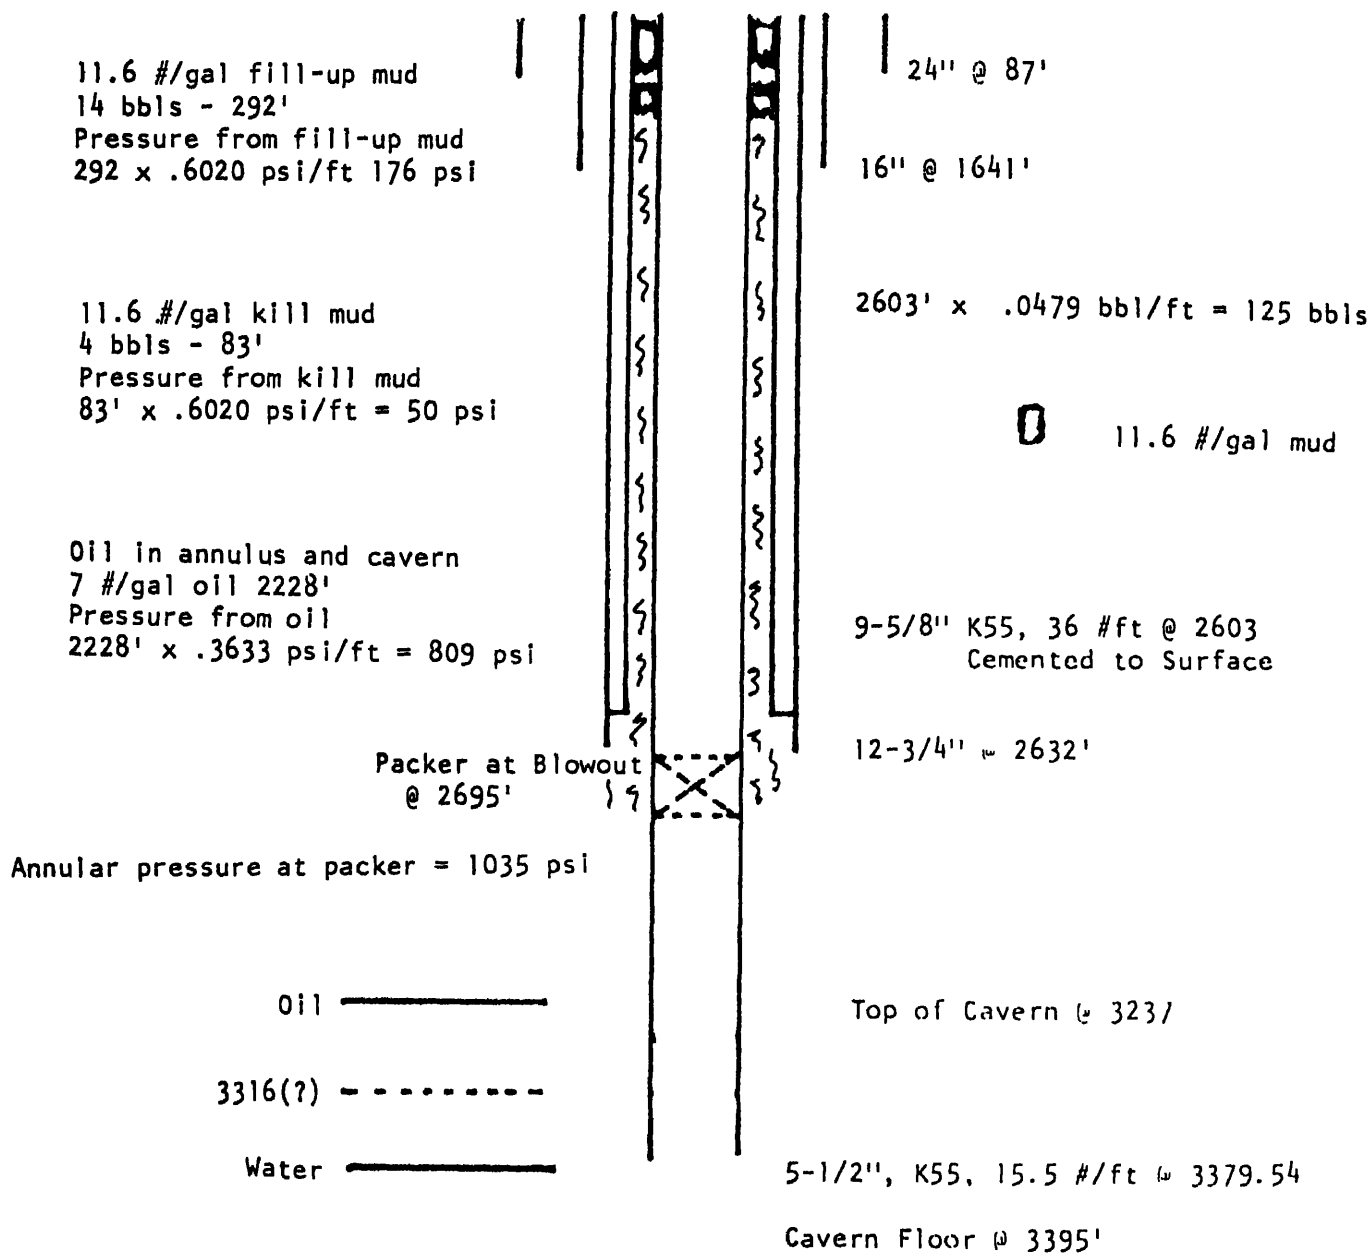
Figure 2-D

After pulling 14 joints of 5-1/2" tubing, the pressure in the annulus opposite the packer (corrected for depth, and annulus fill-up with 14 bbls of 11.6 #/gal mud) would have been 1035 psi (Figure 13) (Figure 2-D).

Cavern Pressure Reduced to 50 psi Potential
Condition on Well 6 After Pulling 14 Stands
of Tubing.

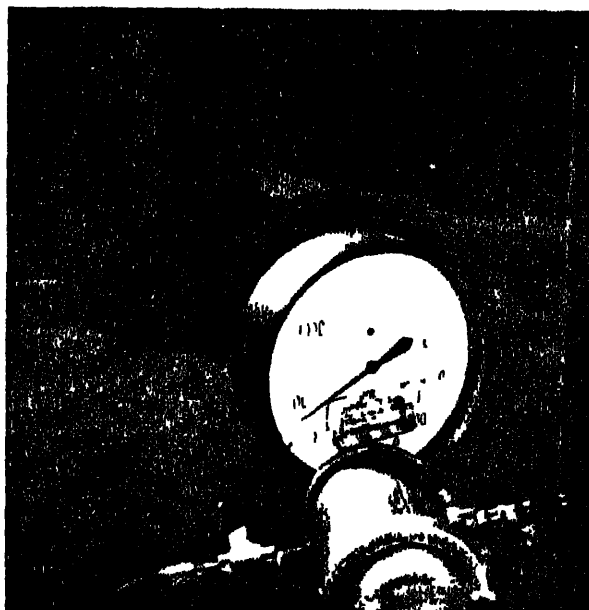
OIL COATED PACKER

TEST w/OIL
PACKER SLIPPED @ 550 PSI
THEN HELD @ 650+ PSI
MOVED AT 700 PSI

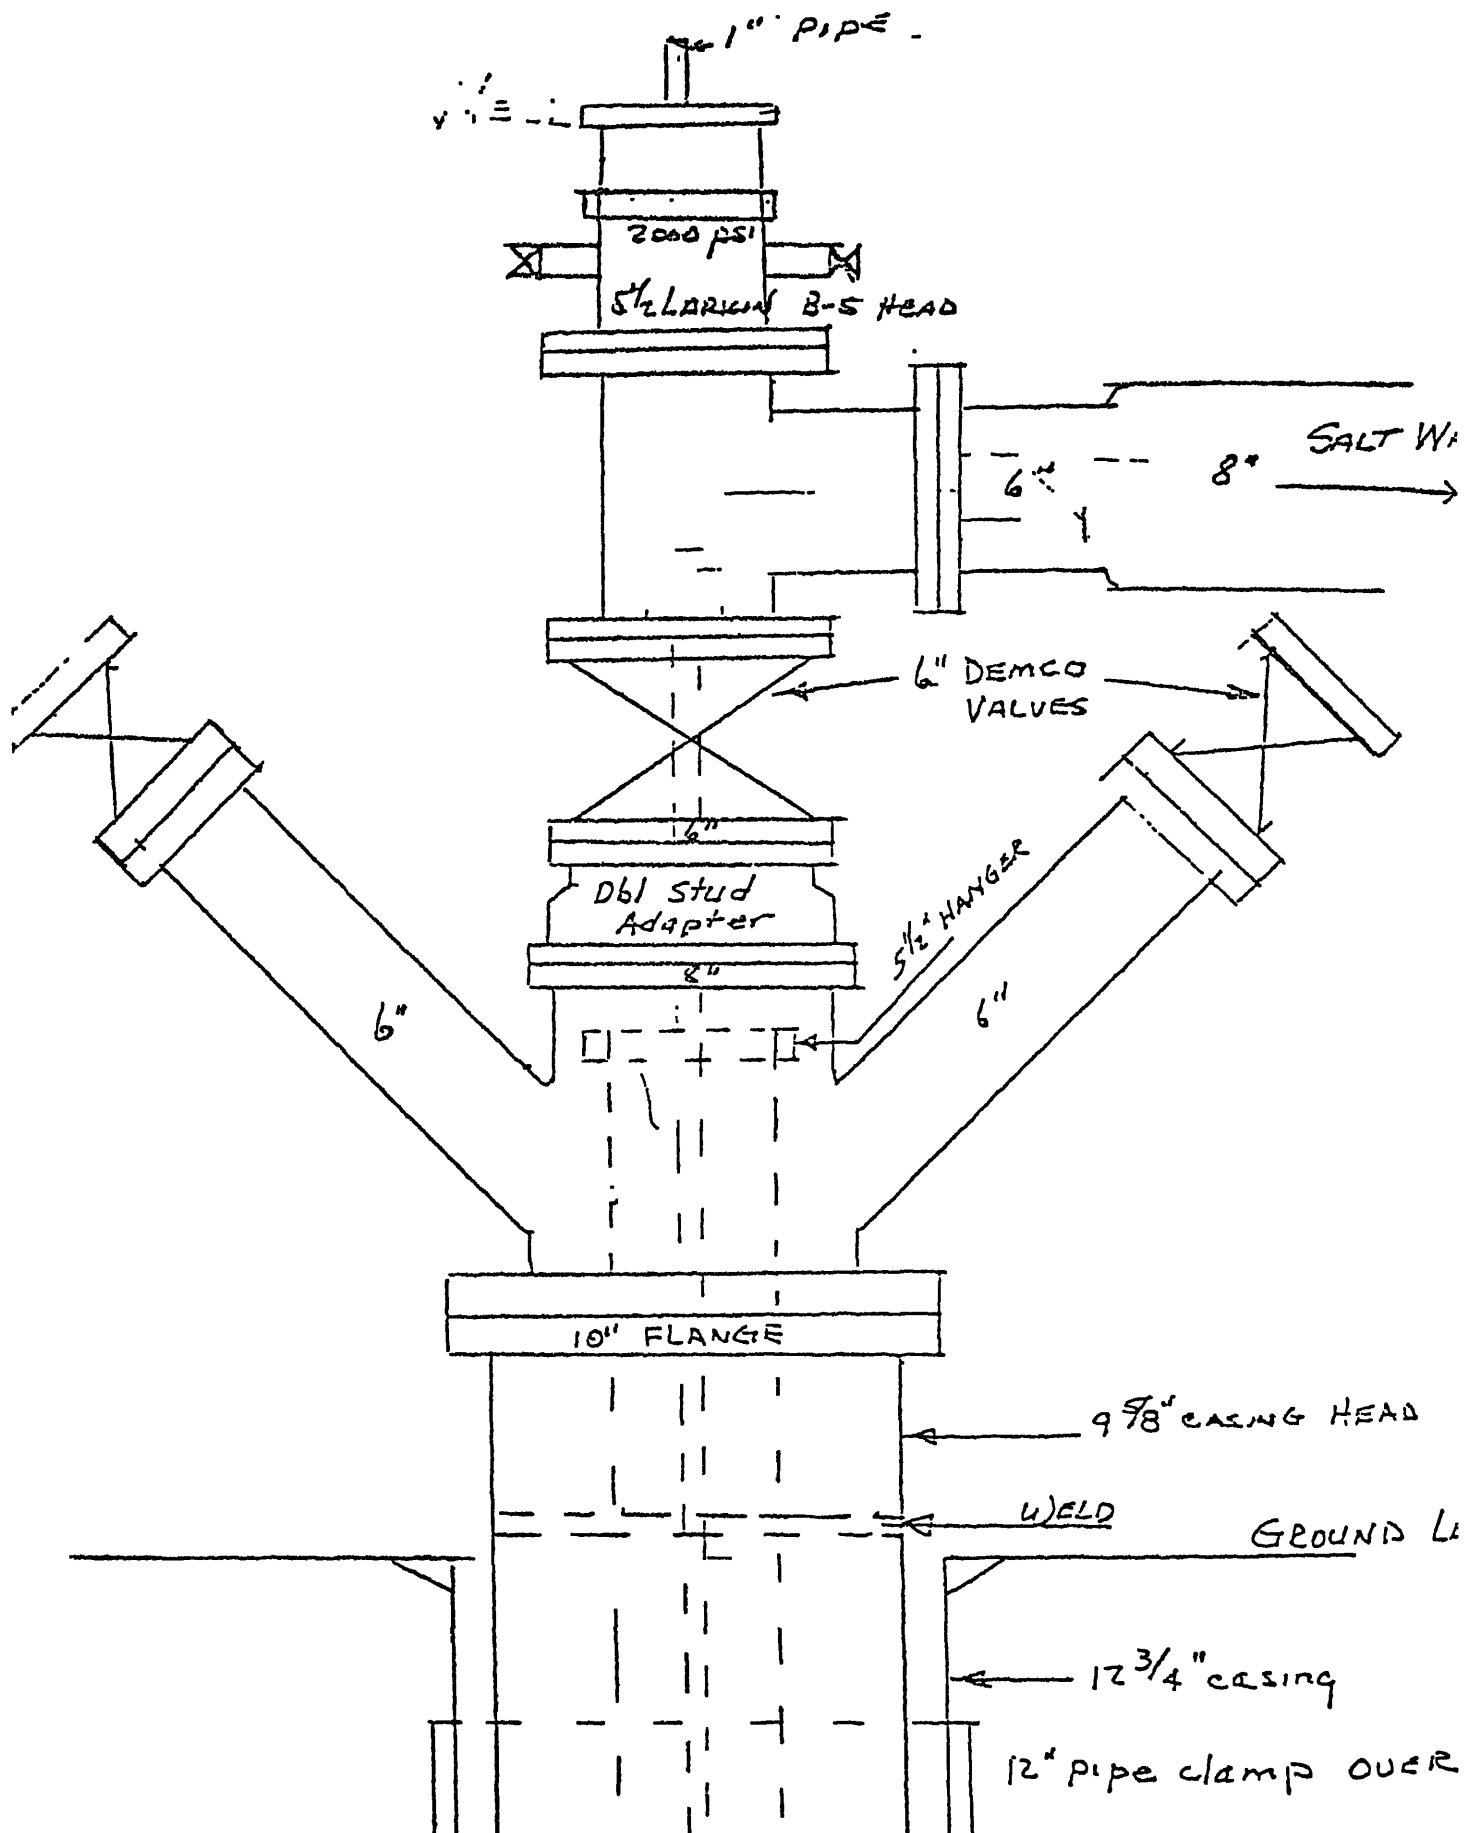
NO 6 WELL CONFIGURATION WHILE SETTING TAM BRIDGE PLUG

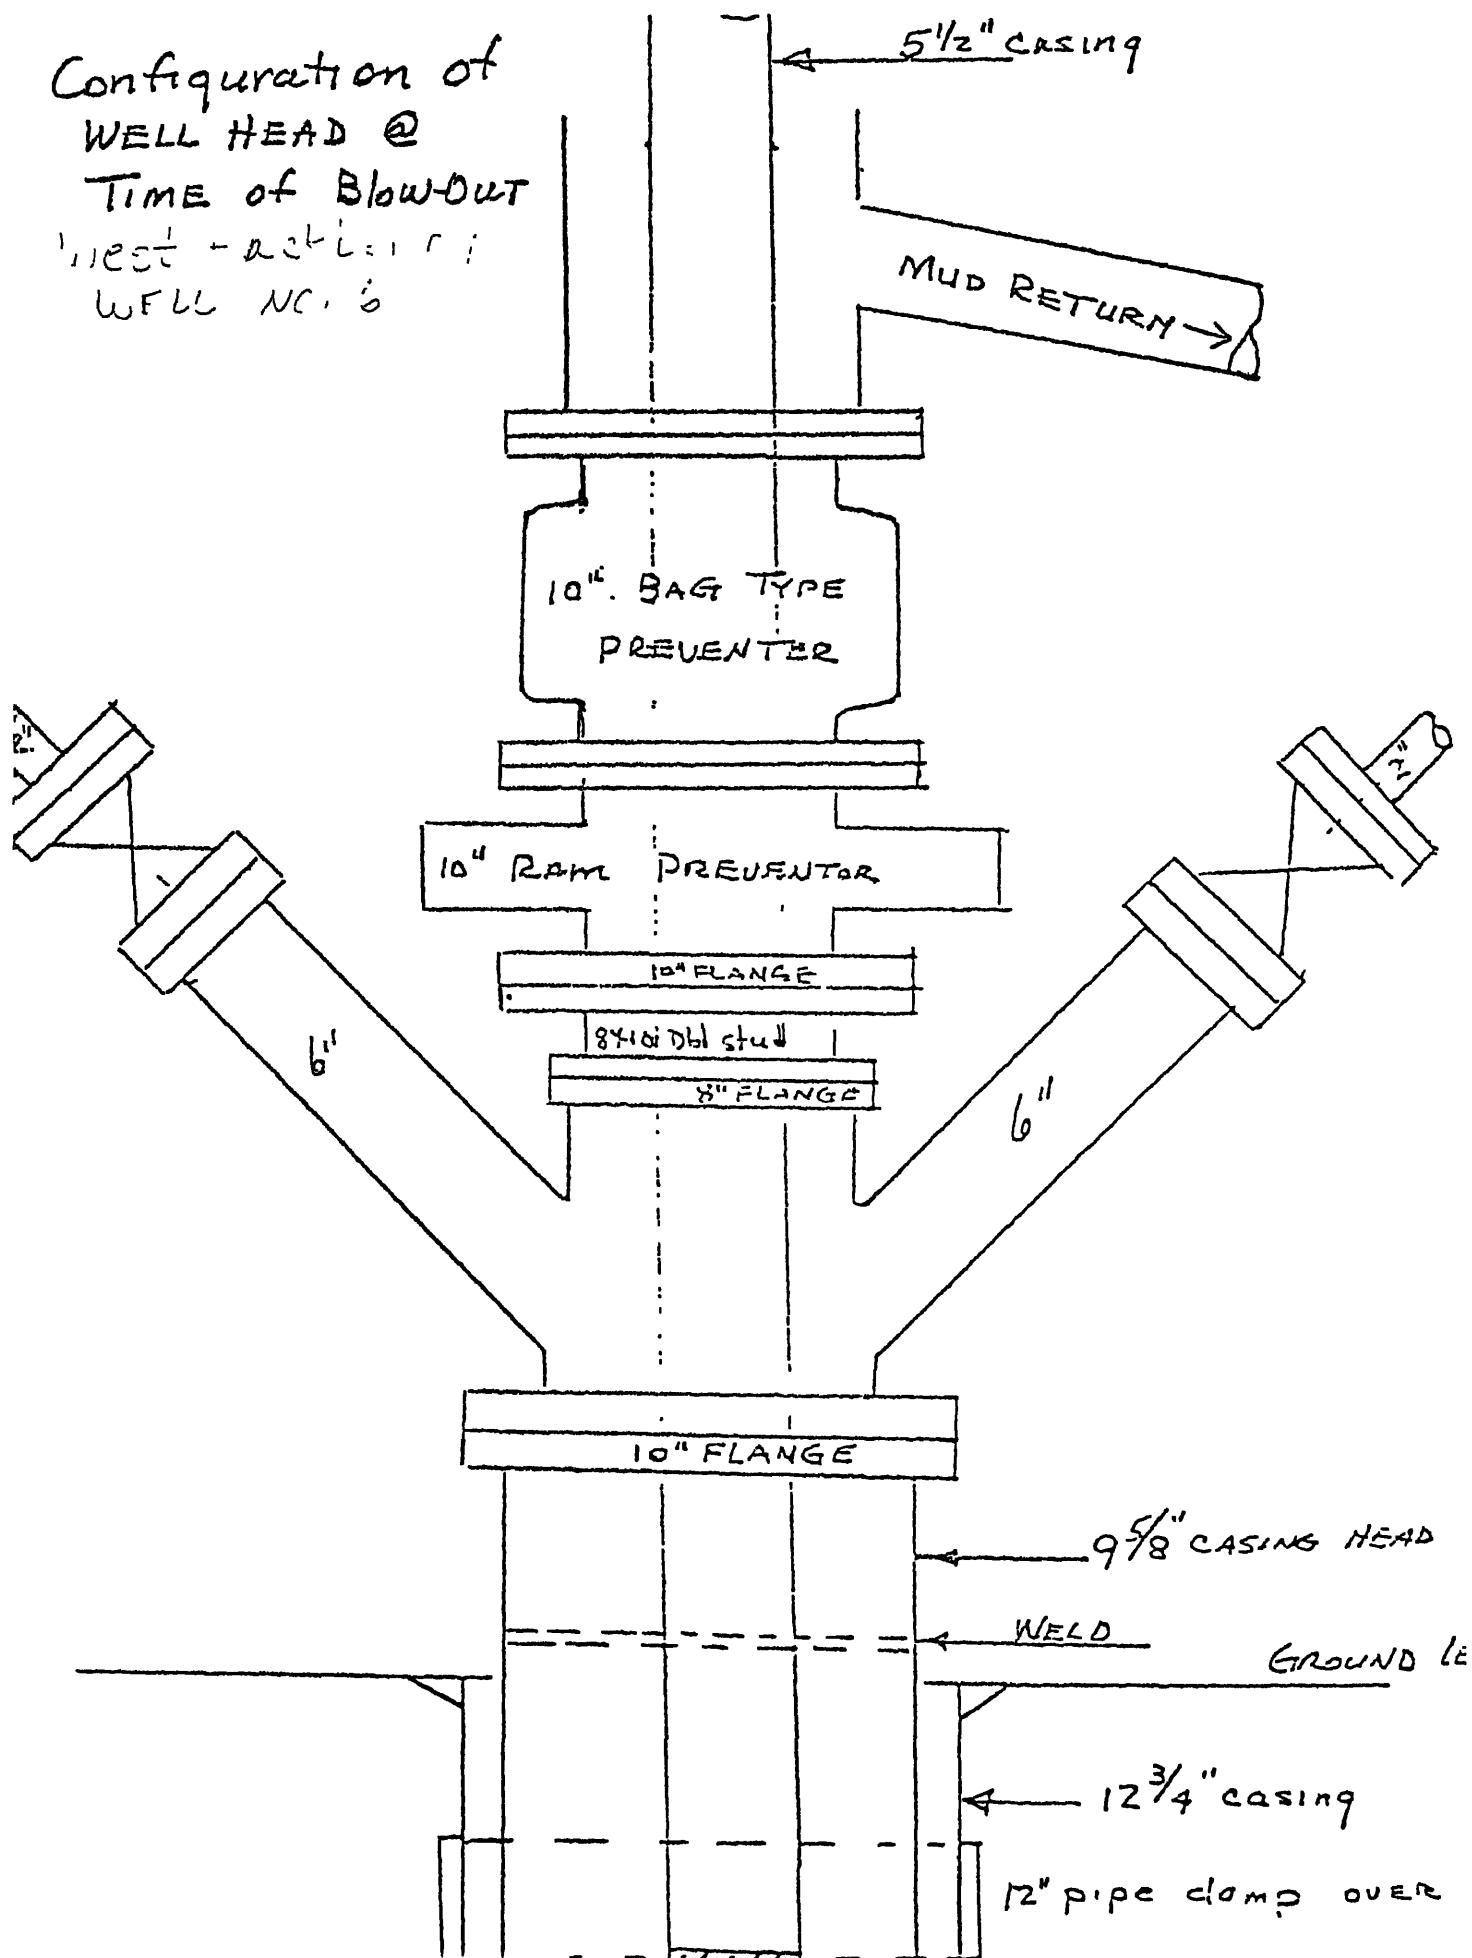
COMPLETED WELL No 6 WEST HACKBERRY
